Mottisfont Tythe Barn,
Mottisfont Hampshire
(SU 325 268)

Historic Building Record
2009-2010

November 2010

by
Martin Wilson
for
Middlebridge Services Ltd

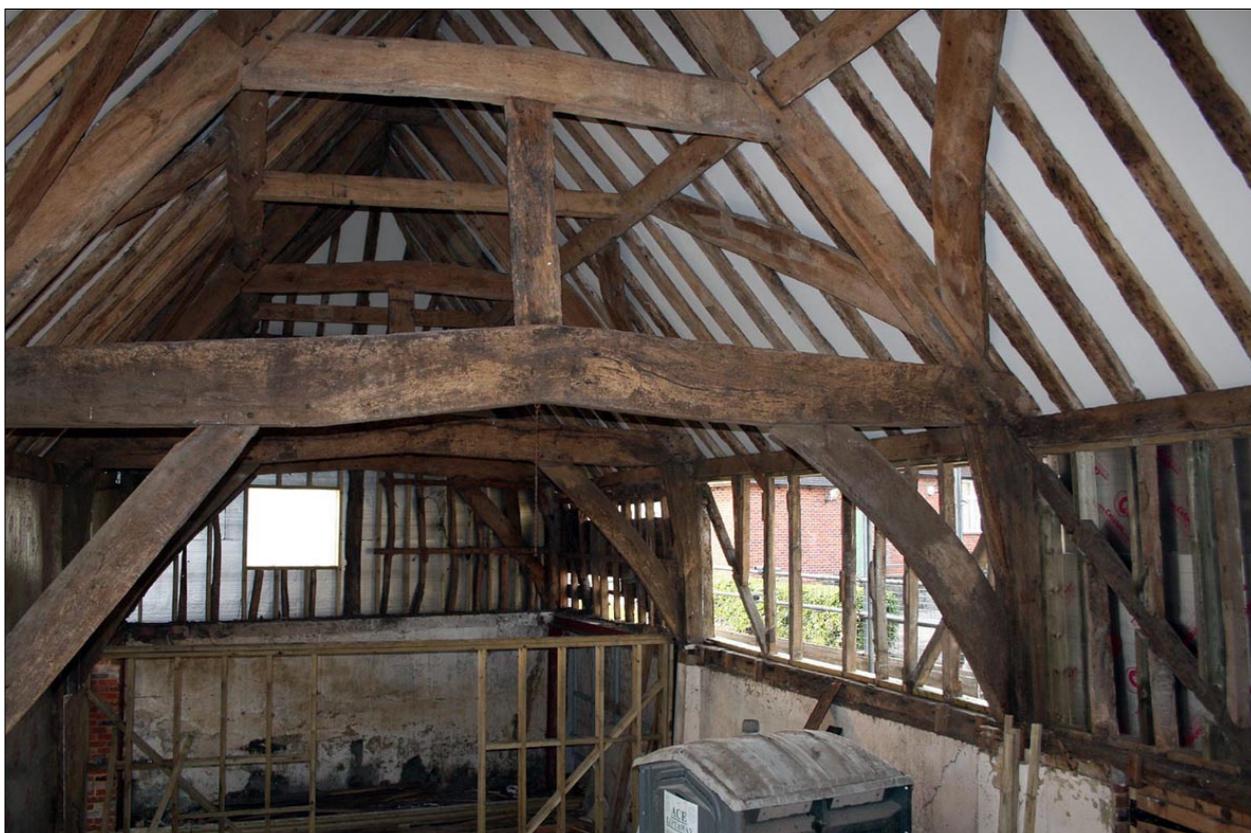
- 4.4 The north elevation (Fig.10) consists of a wall of red brick (rendered and whitewashed on the interior), built to a height of c.2m upon a foundation of re-used limestone blocks. The wall extends throughout Bay 2, to the entrance in Bay 3, before continuing in Bays 4 and 5. Except for the principal posts, only the upper half of a timber framework is present in the north elevation, which rests upon the wall, and is panelled in weatherboards.

Fig. 10. General view of the west and north elevations, facing north-west from Bay 3.

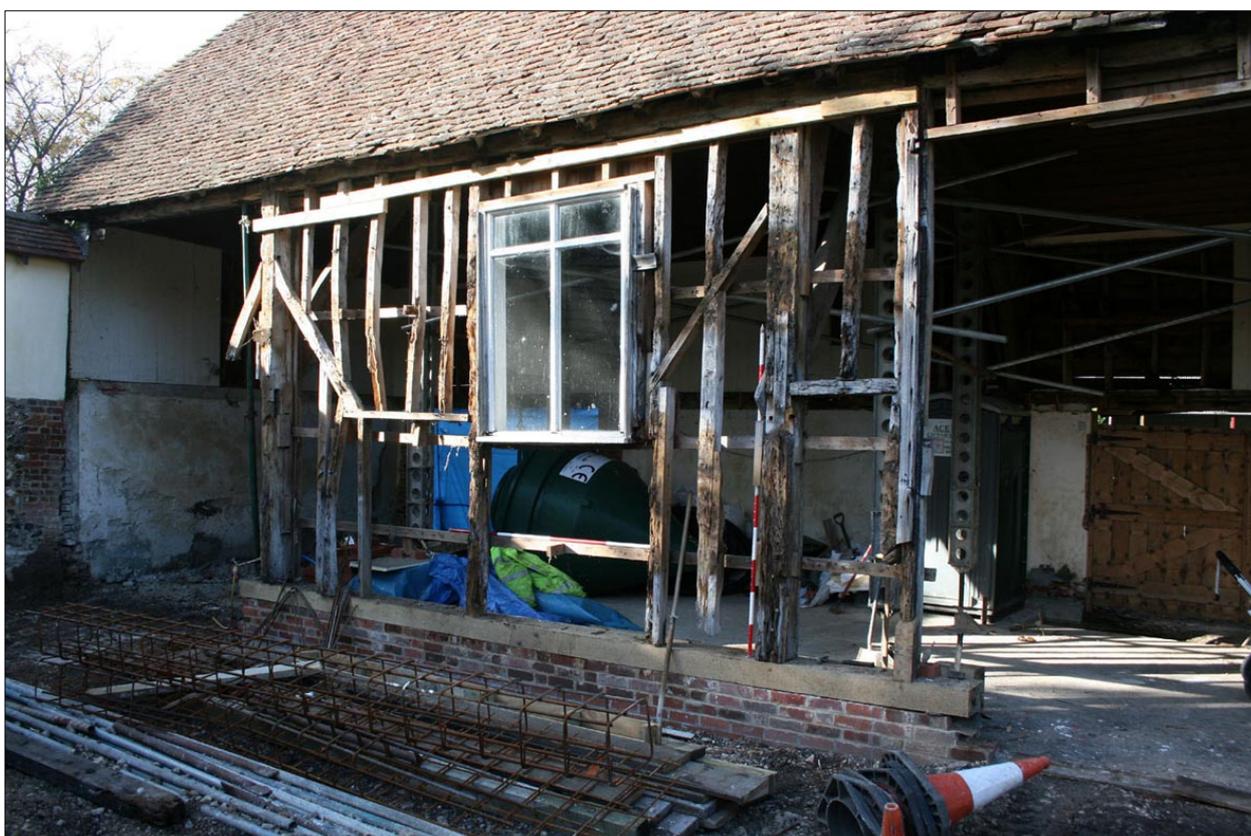
- 4.3 Removal of the weatherboarding from the south elevation revealed that many of the structural elements had either seriously decayed or were completely missing; sills were absent and most main posts, rotten at the base, were scarfed with new oak timber during the restoration (Fig.11). Other than the principal post of cross-frame 2, there was apparently no Phase 1 or Phase 2 timber work present after the removal of the 20th century cladding⁹; a possible open access to an adjacent building in the 19th century (*ante*. 3.1) might account for this. The priority to secure the structural stability of the south frame determined the course of the restoration programme, during which the roof was supported by a purpose-built steel scaffold.

Fig. 11. Bay 1 and 2. Remains of medieval and post-medieval timber framework in the south elevation. Facing north-west.

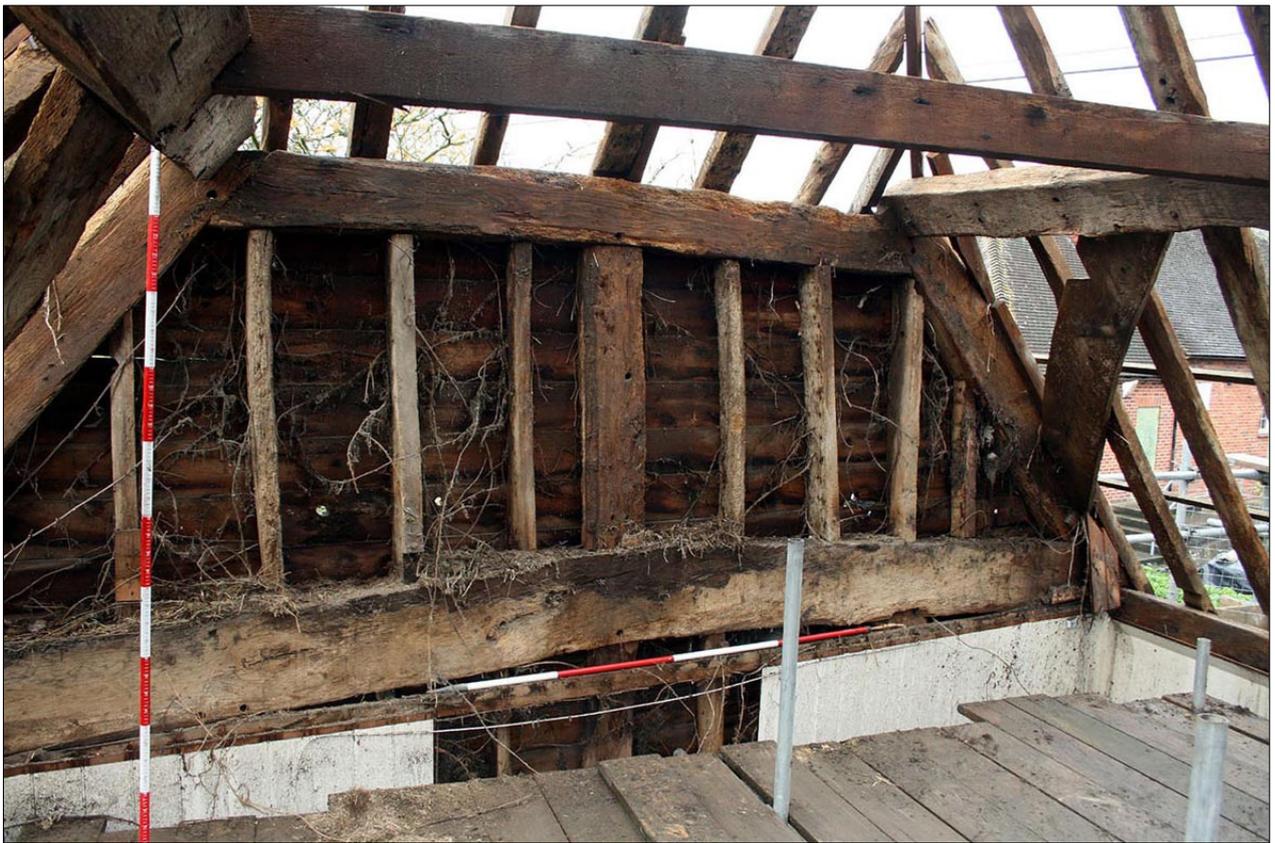
- 4.5 Truss 1 is a replacement timber frame (Fig.12), and is markedly different from the fan truss of the east elevation. There are no tension brace mortises present on the tie beam. The original (Phase 1) curving wind-braces are present on both sides of the roof. Truss 2 (Fig.5) is faced up to the west. The principal rafters have threaded purlins, which is a feature of each original cross-frame (Fig.14). Medieval carpenter's marks, roughly-scored Roman numerals, are visible across most of the facing side joints of Truss 2 (Fig.15), and on the outer face of each wind-brace. A second series of neatly-chiselled carpenter's marks are present on the timber of each joint (Fig.16) indicating that the frame was dismantled and re-erected. The style and technique used for these marks suggest that the reconstruction event took place in the 18th or early 19th century. Notably, the wind-brace mortises on Truss 1 (S) (Fig.17) and Truss 2 (N) are exceptionally wide-fitting when compared with those in the other bays, with rough saw-marks extending outside each mortise on Truss 2 (N), which gives the impression of a 're-jigging' during (re-)construction. Both the northwest wind-brace and the southeast wind-brace have a large right-angled notch cut out of their upper sides at some later date, the reasons for which are uncertain (Fig.12). The common rafters are predominantly replacements. On the south side they include a very weathered 'split' mid-rail which has stave holes and a 'v'-groove clearly visible. There is a 'daisy wheel' inscribed on the face of the tie beam (south side) (Fig.13), a means by which a medieval carpenter would calculate the angles and layout of the building by compass geometry¹⁰.

Fig. 12 (above). Bay 1, truss 1. Facing north-west.

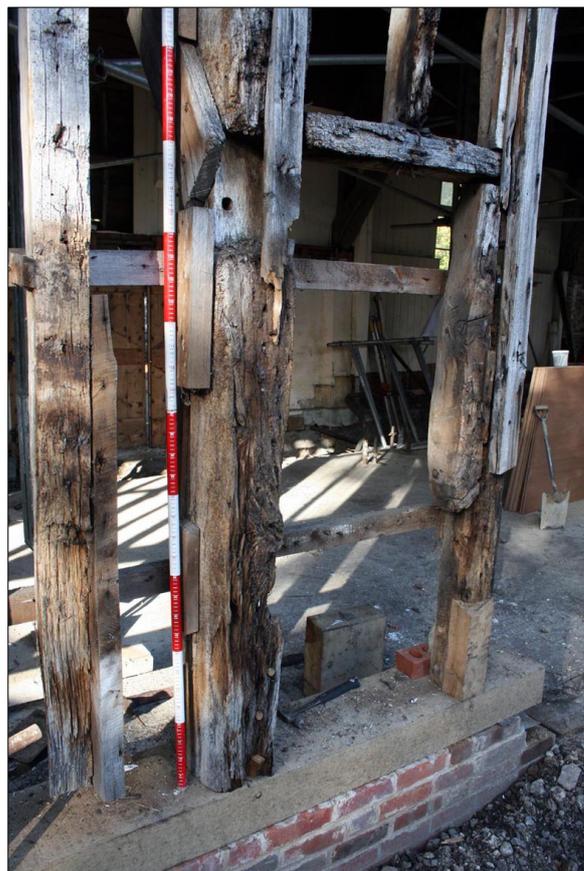
- 4.6 The north and south elevations retain their original principal posts. In the preliminary analysis (Roberts, 2007) it was suggested that this bay may have contained the Phase 1 wagon entrance, on account of bays 4 and 5 having evidence for loft floors, and given that wagon entrances were usually in the centre of a barn in order to minimise labour. In this respect; therefore Bay 2 would have functioned as a 'central' bay. In support of this theory there are no mortises present in posts 2 or 3 for down-swinging curved tension braces (Figs.18 and 20), as seen elsewhere along the north elevation. The timber framework of the north elevation, including wall plate, belongs to Phase 2; the lower beam of the framework consists of a re-used mid rail turned onto its side (Fig.20). The lower part of the south elevation was not seen by the archaeologist during the development, although he was informed that there were no remains of sill beams or the original ashlar plinth. Few storey posts (i.e. those which rise between and wall plate) survive in the south elevation, their lower portions rotted away, were scarfed to new timber during the restoration (Fig.19).

Fig.19. Cross-frame 3,(S). Principal post (centre) and Phase 2 storey posts, set upon new sill. Facing north-east.

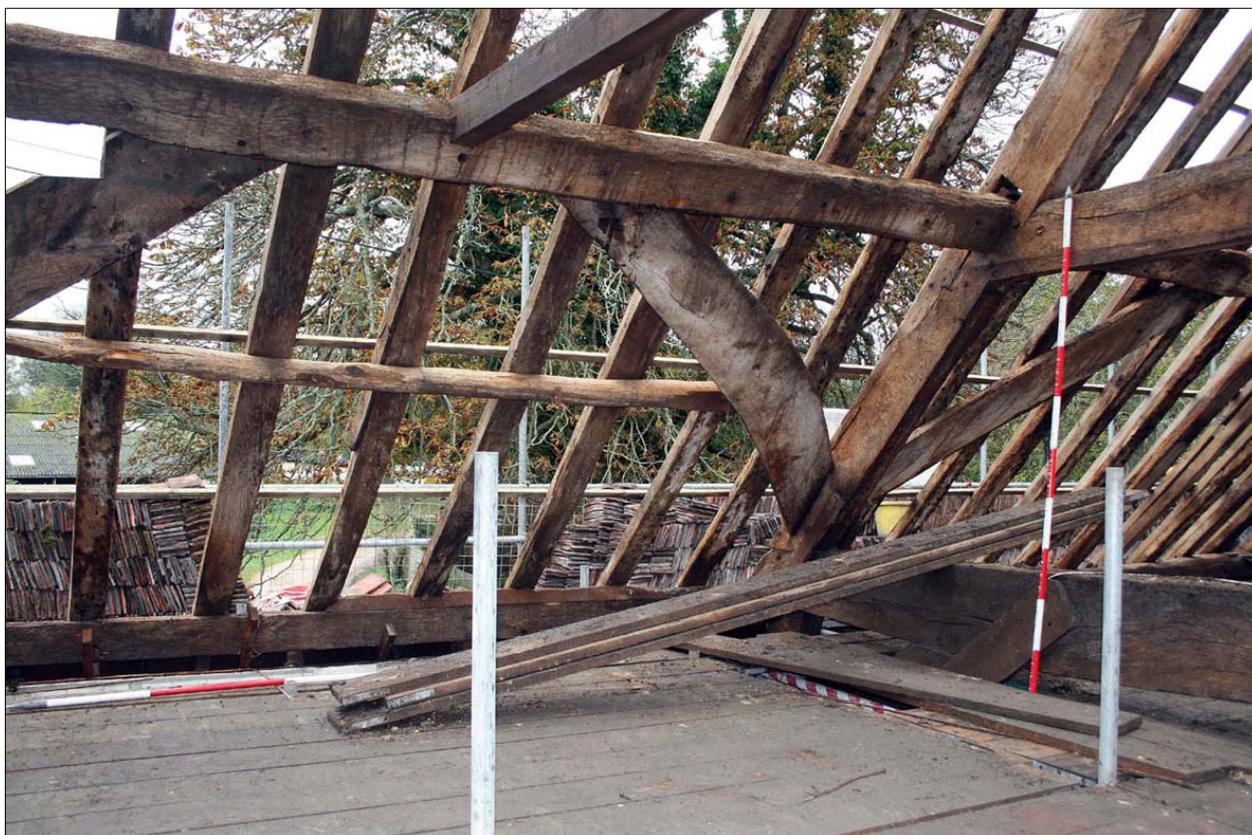
- 4.7 Most of the roof frame (i.e. with the possible exception of the common rafters) belongs to Phase 1. Truss 3 (Fig.5) is faced up to the west. Medieval carpenter's numerals are present, as are a series of numerals of probable 18th / early 19th century date (Fig.21). 'Daisy wheels' are also present (Figs.21 to 23). The original wind braces are intact. Notches, at right-angles, have been cut out at a later date, the reason for this is uncertain (Fig.24).

Fig.24. Bay 2. the roof structure. Facing north-east.

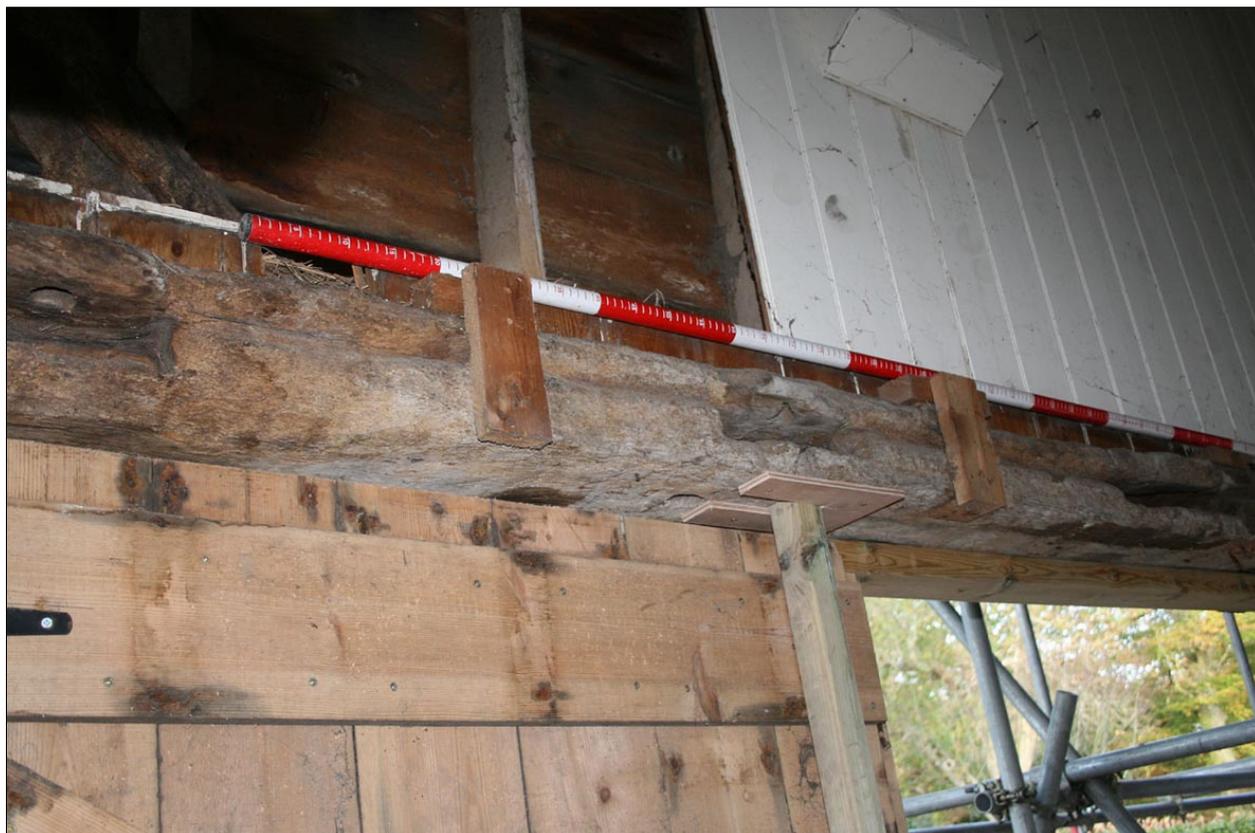
- 4.8 Traditionally, the central bay was the loading bay. It was used as a wagon entrance in Phase 2 (i.e. the 18th / 19th centuries). The lintel above the entrance is a re-used mid-rail turned on to its side (Fig.25). On cross-frame 3 (i.e. on the west side of the entrance) there is a mortise for a down-swinging tension brace which would have been attached to a bridging beam (similar to mid-rail), precluding an original wagon entrance in this bay. Peg holes on the principal posts of cross-frame 4 denote the position of a mid-rail, although there is no mortise for a central stud (Fig.6). There were apparently no remains of sill beams or the original ashlar plinth in the lower part of the south elevation.

Fig.25. Bay 3. A re-used mid-rail acts as a lintel above the entrance to the Phase 2 (i.e. the 18th / 19th centuries) loading bay. Facing north-east

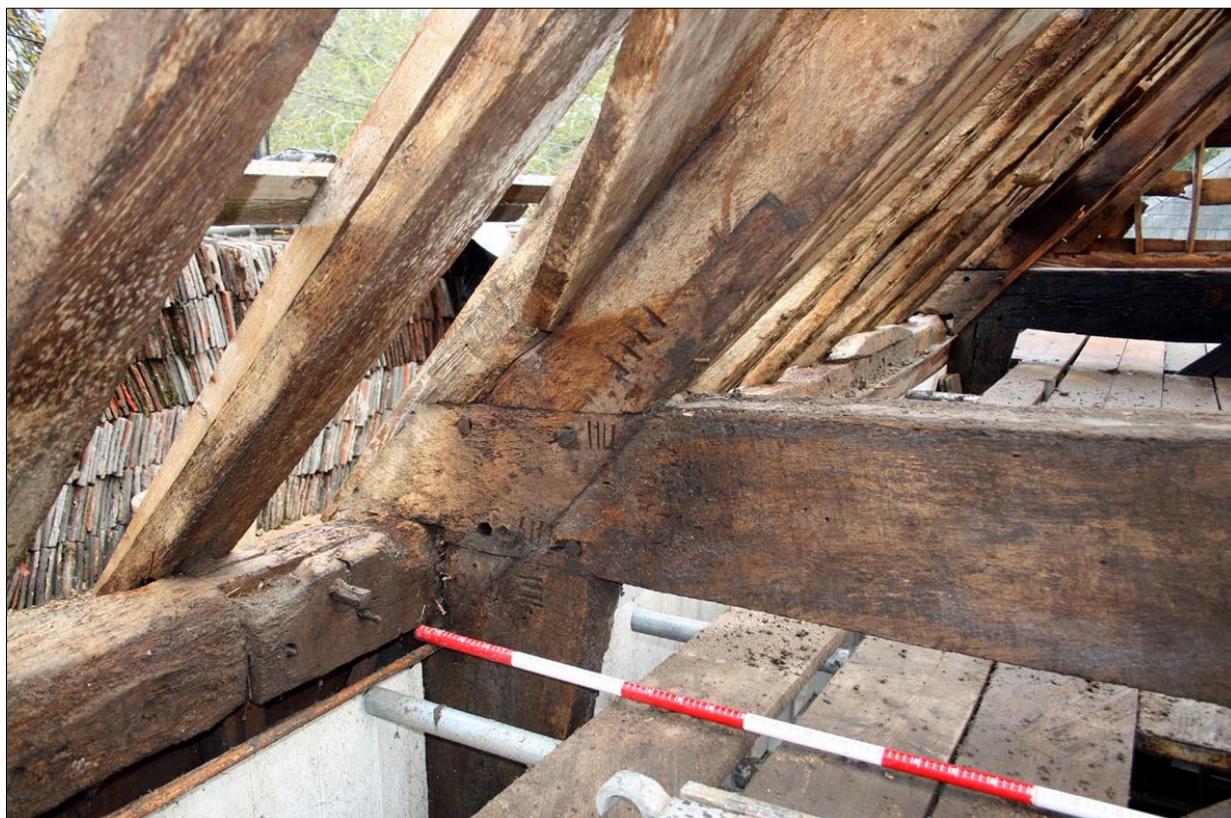
- 4.9 With the possible exception of the common rafters, the roof frame belongs to Phase 1. As with Trusses 2 and 3, Truss 4 (Fig.6) is faced up to the west. Medieval carpenter's numerals are present, as are a series of numerals of probable 18th century date (Fig.26).

Fig. 26. Bay 3, truss 4. Post and truss joint. Facing north-east.

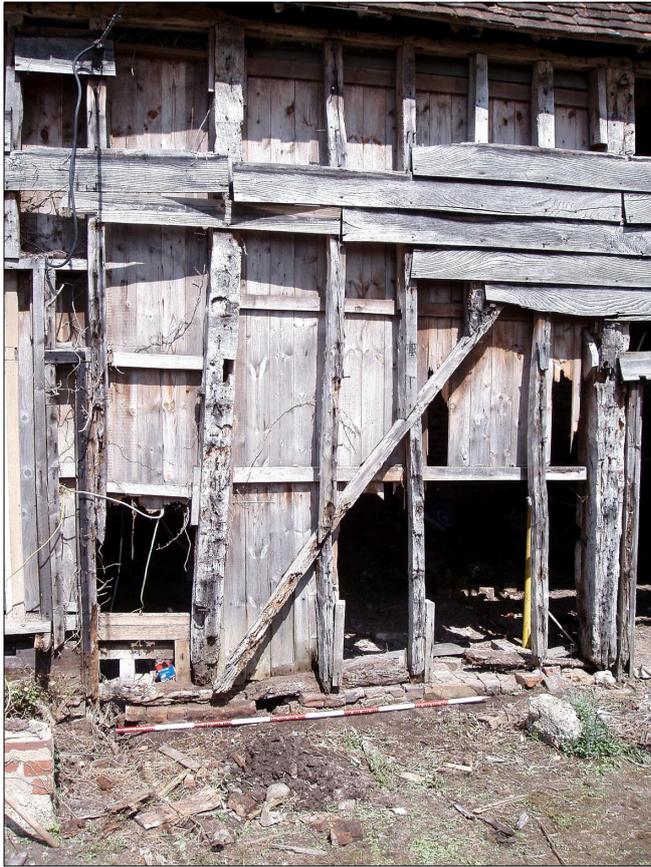
Fig.27. Bay 4. Condition of Phase 1 and Phase 2 timbers in the south elevation. Facing north.

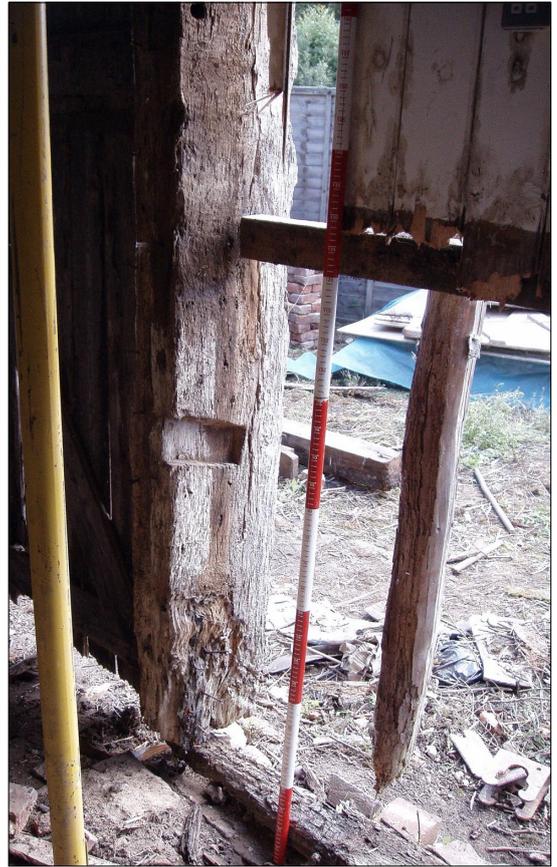
- 4.10 The lower half of the north elevation consists of a brick wall, to a height of c.2m, upon a foundation of re-used limestone blocks. The wall extends throughout Bay 5. On top of the wall, mid rails have been laid, turned through 90 degrees, to form a sill for the timber framework of the upper half of the elevation. Due to the constraints of visibility, it was not possible to ascertain whether there was evidence for a down-swinging tension brace in post 4.
- 4.11 In the south elevation, there was no trace of a sill beam; the lower parts of principal posts and storey had rotted away (Fig.27). Symmetrically, opposed mortises cut diagonally into inward sides of the 2nd and 3rd principal posts indicate the probable position of a manger; a Phase 2 feature (Fig.28).

Fig.28. Bay 4. South elevation. Mortise for Phase 2 manger; principal post 4 Facing south-east.

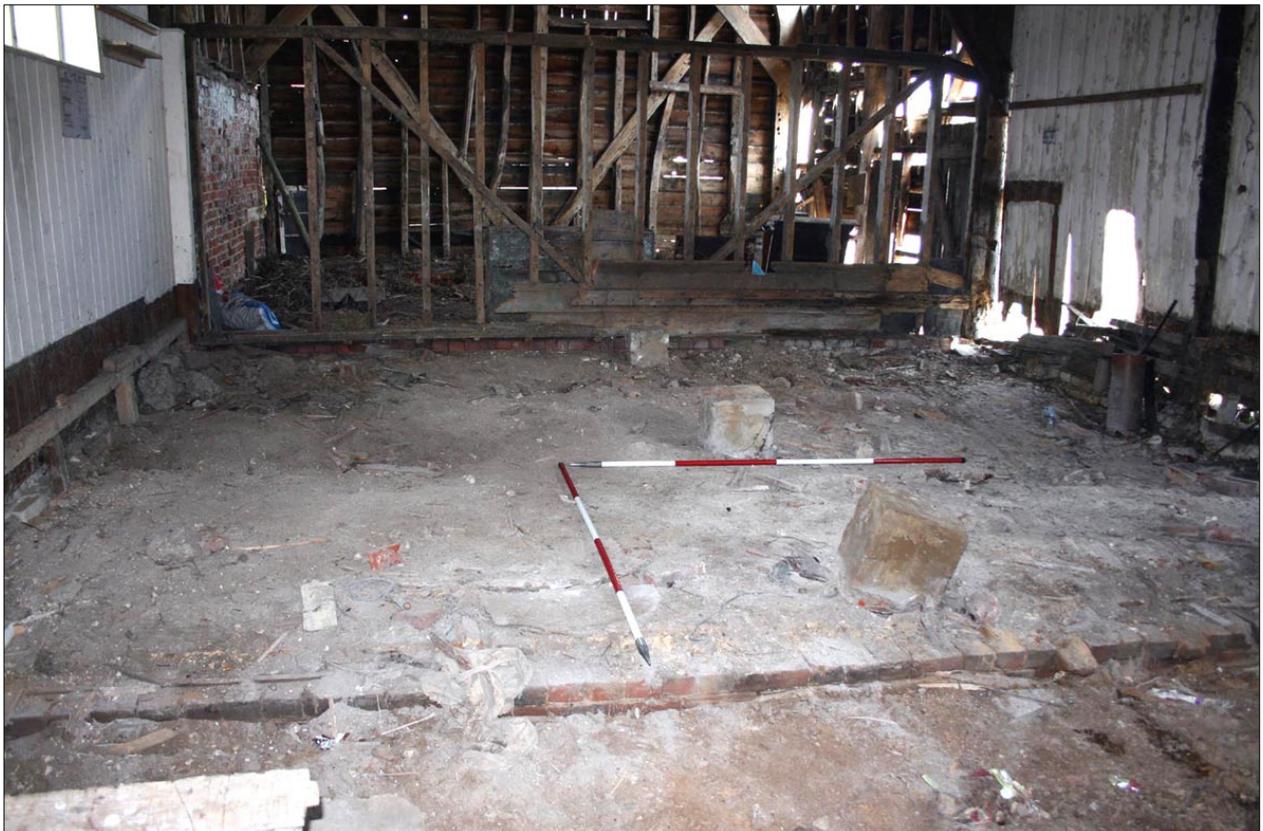
- 4.12 Removal of the village hall stage in Bay 4 revealed a floor of rammed chalk, forming a raised area (Fig.29) and a brick-lined drain running north-south beneath the north and south walls of the building (Fig.30). In contrast, Bays 1 to 3 had opened up directly onto geological stratum, while the floor of Bay 5, the stable, was cobbled. The dimensions of the bricks (6" x 1½ x 1") suggest a post-medieval date. Ground-work also revealed evidence for a wall of an earlier building on the site, approximately 1m west to cross-frame 5. It consisted of a linear void, to a depth of c.0.4m, in a layer of rammed chalk, filled with 18th–19th century soil and rubbish (Fig.31). The void had evidently been caused by the removal of superstructure; at its base a rotten timber, probably the remains of a sill beam was removed by the ground-work team. Since a sill beam would have sat proud of any floor, the rammed chalk was clearly a later event. Hand-made bricks used for the foundations of internal partitions were the same dimensions as those on the outside wall of the building, suggesting the same chronology. The bricks used inside the building were un-mortared.

Fig.29. Bay 4. Floor of rammed chalk forming a raised area, revealed after the removal of the village hall stage. Facing east.

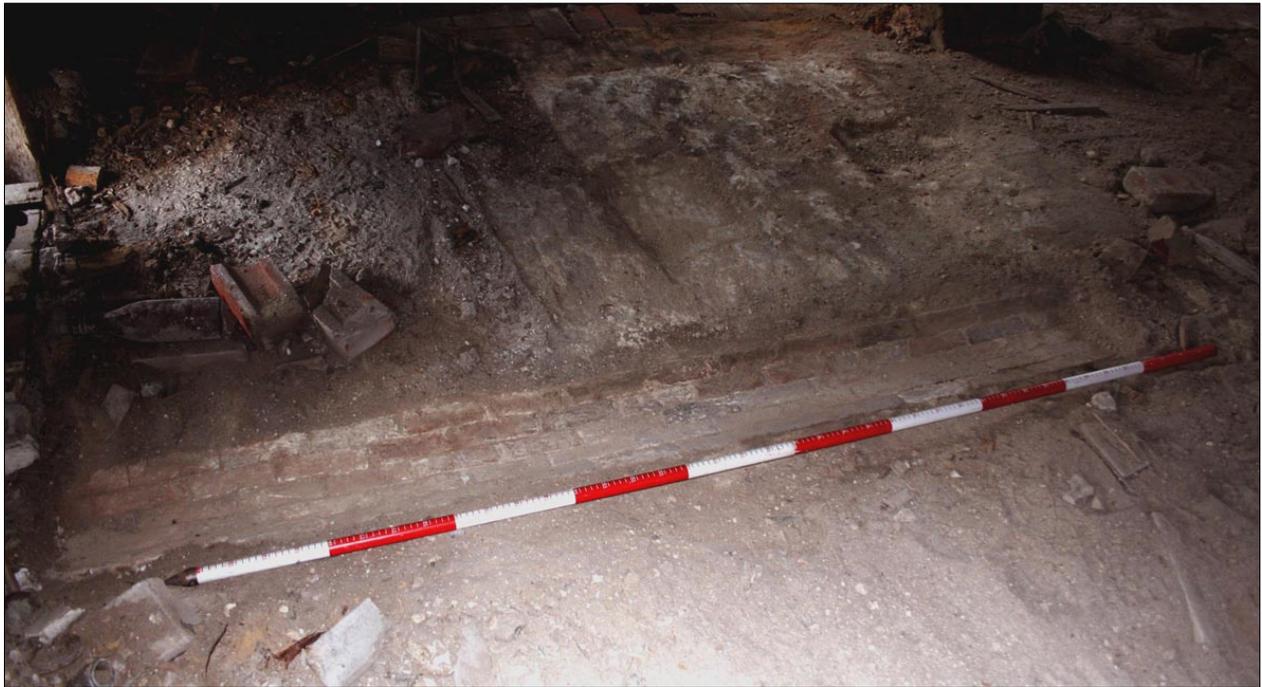
Fig. 30. Bay 4. Brick-lined drain running north-south, and beneath the north and south walls of the barn. Facing north-west.

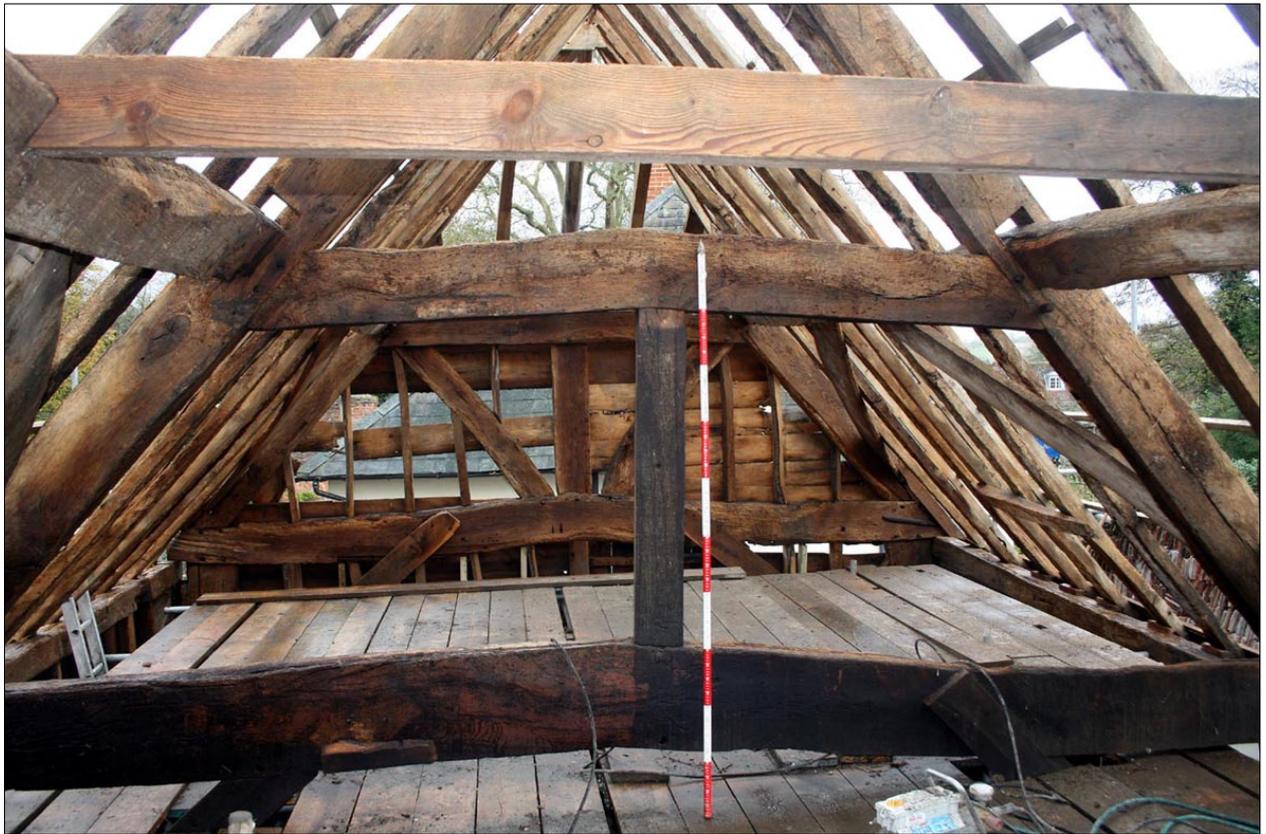
- 4.13 As with Trusses 2, 3 and 4, Truss 5 is faced up to the west (Figs.7 and 32). Medieval carpenter's numerals are present across all main joints, flanked by those of probable 18th century date (Fig.33). Peg holes on the principal posts of cross-frame 5 denote a former bridging beam, together with evidence for a central stud (Fig.7). There are stave holes on the underside of the tie beam (Fig.34), a 'v' groove on its upper side (Figs.35), and stave holes on the underside of the collar beam (see Bay 5).

Fig.32. Bay 4, truss 5. Facing east.

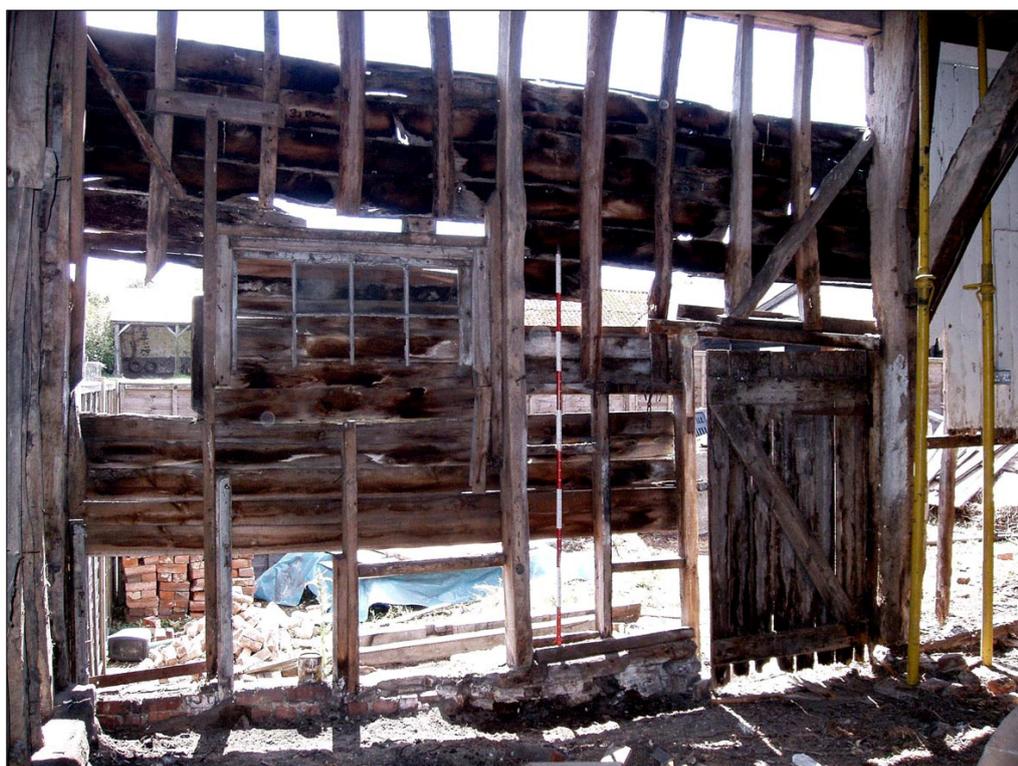
- 4.14 The sill of the southern elevation comprised the remains of rotten timber fragments upon a plinth of assorted bricks. There was a lack of diagnostic carpentry cast doubt on any these fragments being Phase 1 material (Fig.36).

Fig.36. Bay 5. Remains of Phase 2 and modern timbers in the south elevation. Facing south

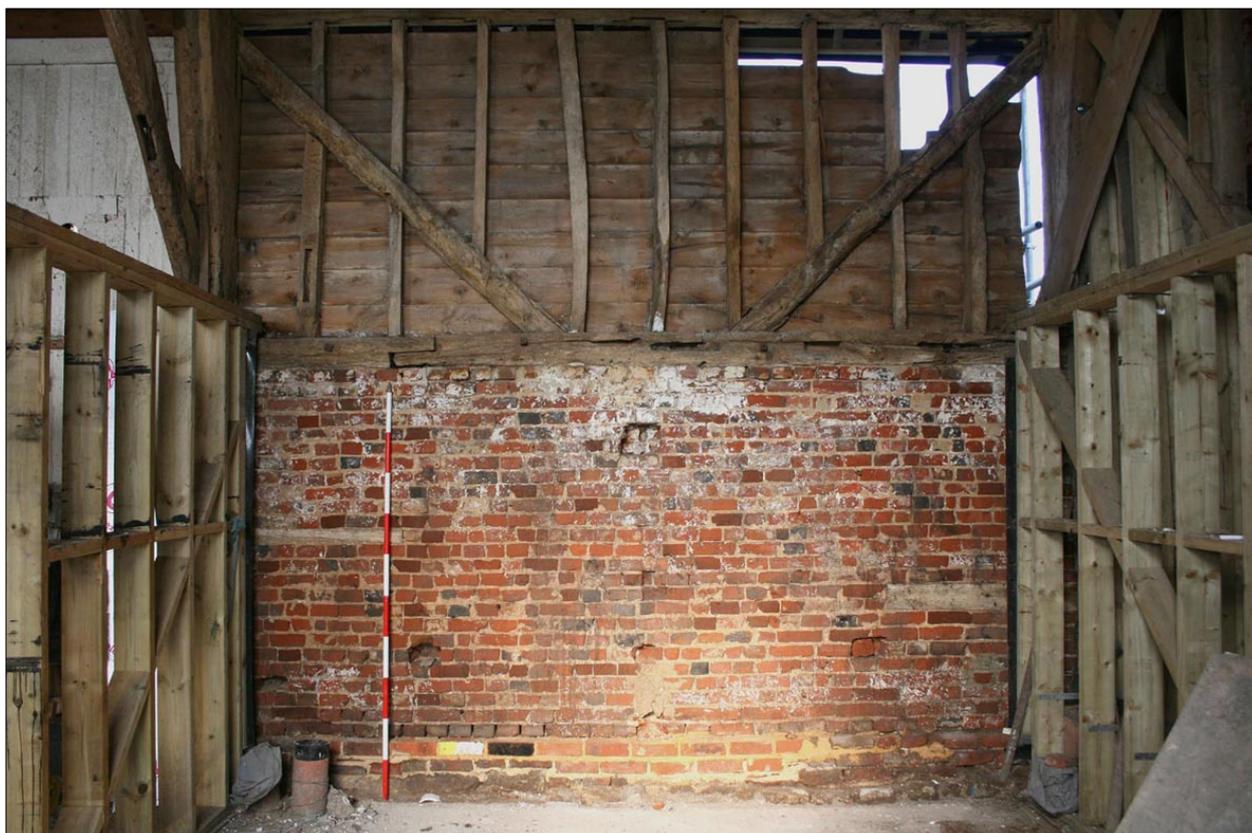
- 4.19 The lower half of the north elevation consisted of a wall of red brick (Fig.37) built upon on a foundation re-used limestone blocks; the latter which is presumed to be salvaged from rubble derived from the priory of Mottisfont (Fig.44). The bricks, handmade, each measure approximately 9" x 4" x 2 1/2" (228.6 x 101.6 x 25mm). The wall comprises a single soldier course, above which there Flemish bond, which gradually becomes irregular in pattern before changing to stretcher bonding, in places reverting to Flemish bond, or an irregular version of it. The wall is understood to date to the reconstruction of the barn in the late 18th / early 19th century.

Fig.37. Bay 5. North elevation. Facing north.

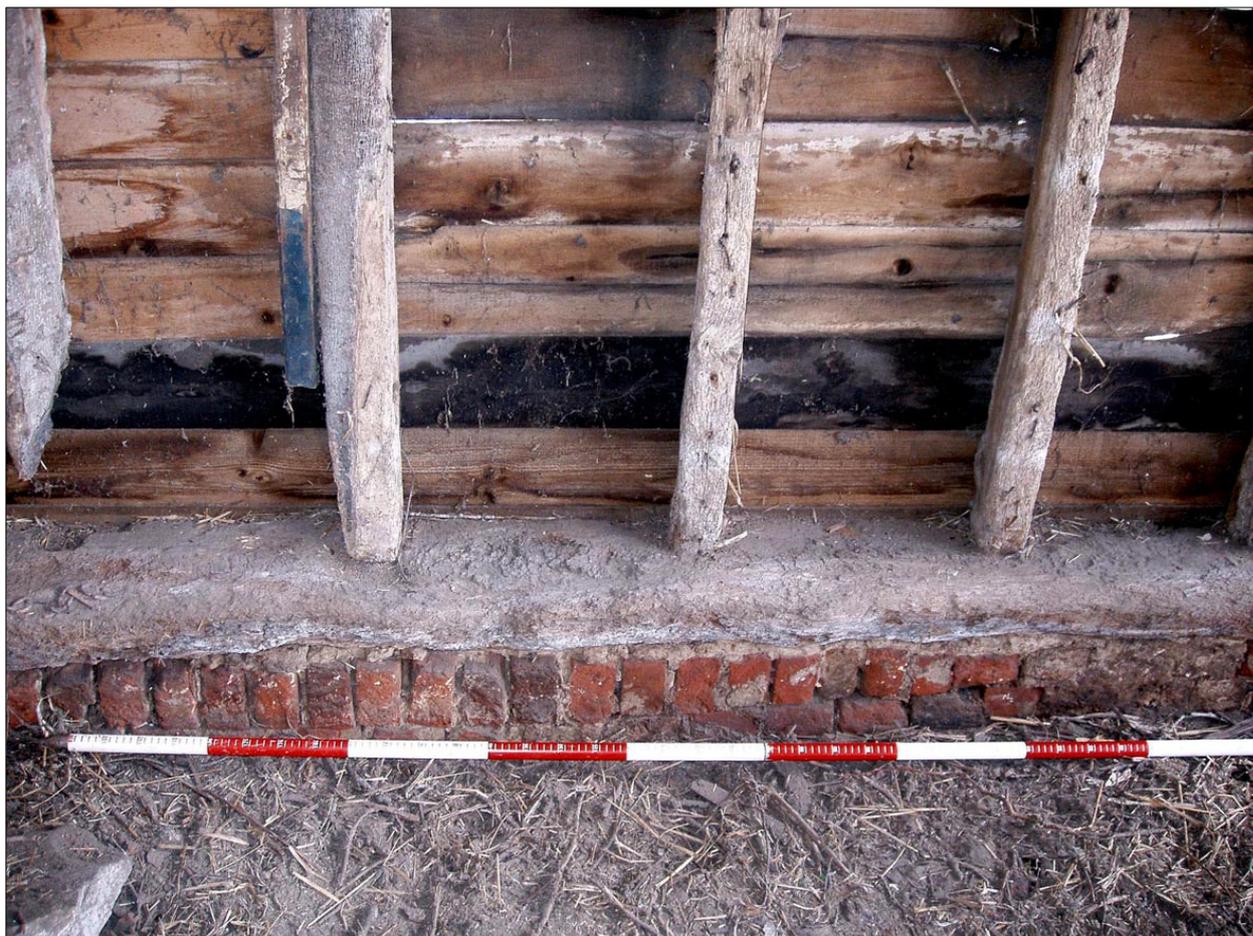
- 4.16 The principal post on the south side remains intact, although was dislodged from the sill beam. The sill beam may be timber from Phase I although the brick plinth is more likely to be Phase 2 (Fig.39).

Fig.39. Bay 5, cross-frame 6. Phase 1 sill on Phase 2 brick plinth.

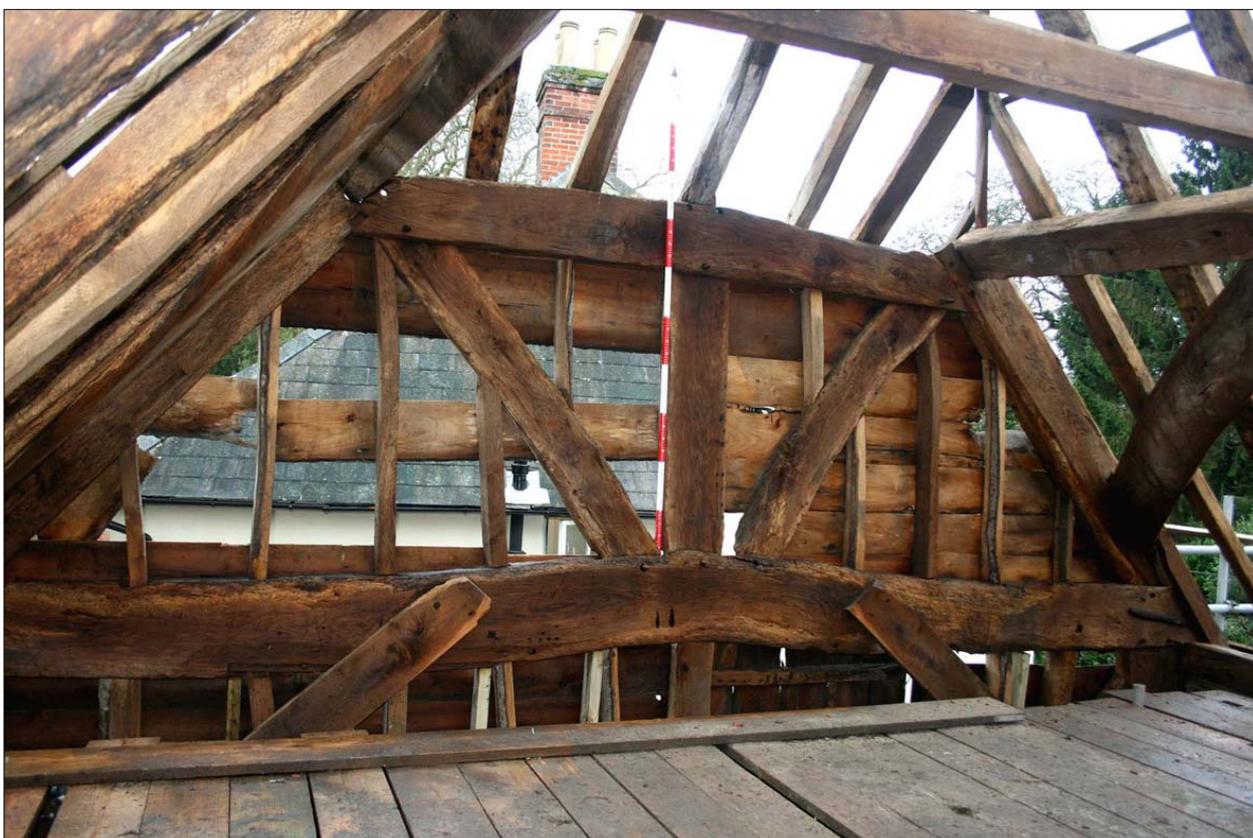
- 4.18 Truss 6 is a 'fan truss', the king strut flanked by out-curving braces (Figs.8 and 40). The truss has been severed just above the purlins (Fig 41). There is a stave groove above the collar, indicating a gable. Medieval carpenter's numerals show that this was indeed the original end frame; these flanked by 18th century numerals as observed on cross-frames 2 to 5 (Figs.41 and 42). Notably, the principal rafter on the north side of cross-frame 5 has no wind brace mortise and has clearly suffered weathering on its east side, indicating that it is a replacement timber that was formerly an end frame (Fig.43).

Fig.40. Bay 5. The 'fan truss' of the east end frame. Facing east.

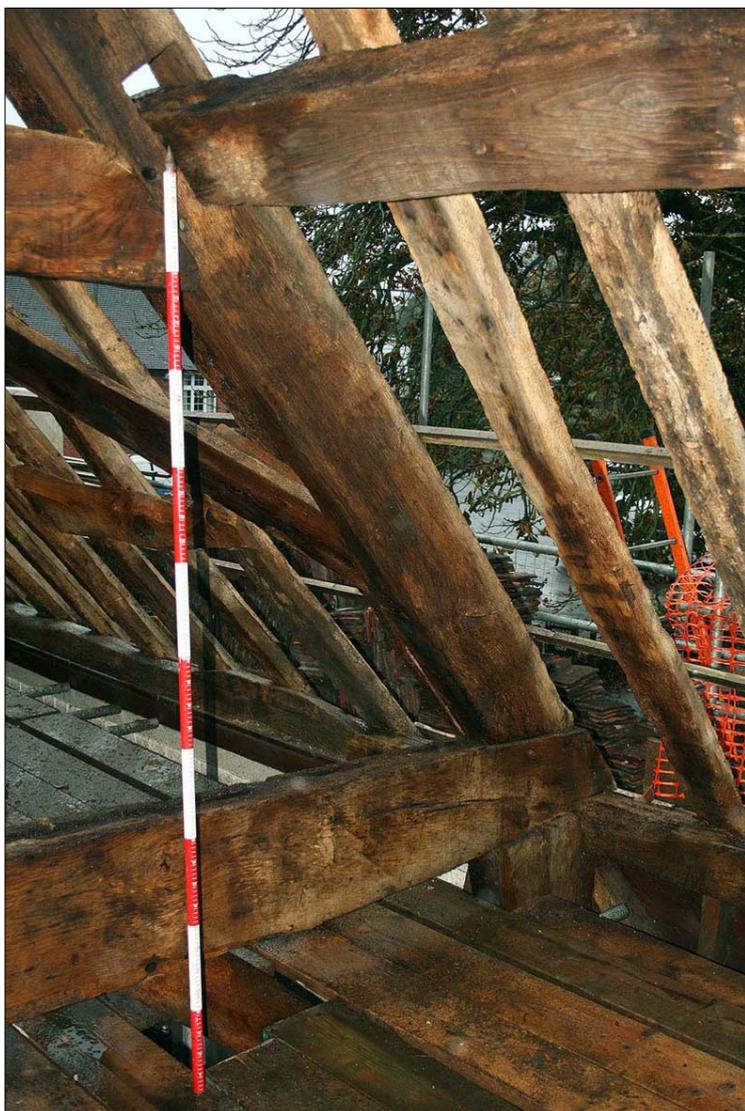
Fig.43. Bay 5. Replacement principal rafter on the north side of cross-frame 5.

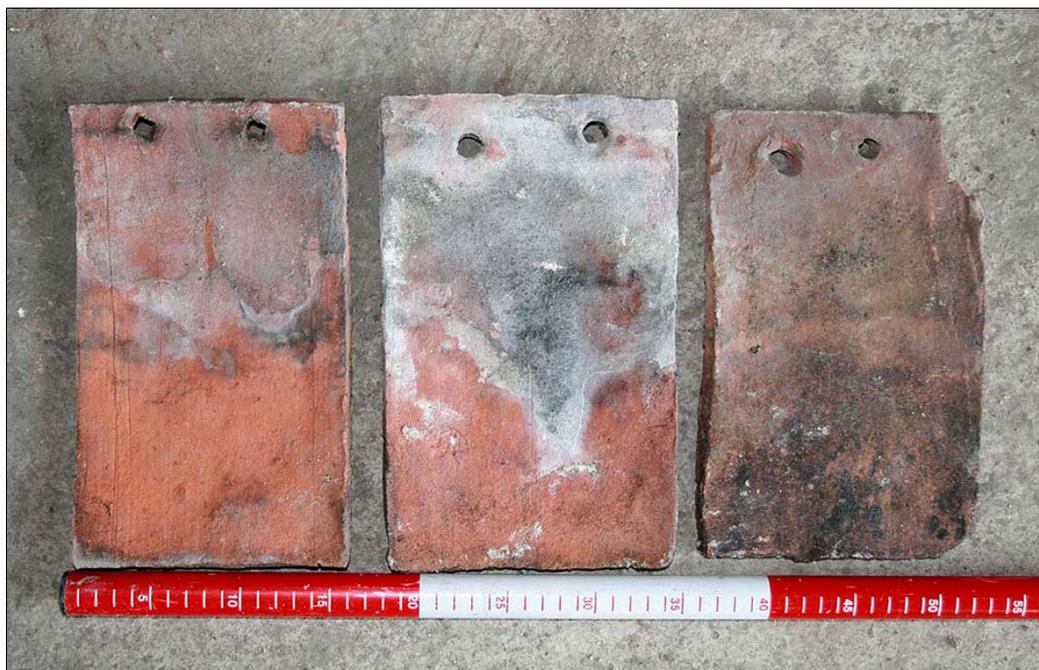
- 4.20 There were two main types of roof tile (Fig.45), the earlier of these having the rounded peg hole, some with rotted wood inside. The tiles each measure approximately 10 3/4" x 6 1/2" x 1 1/2" (273 x 165 x 13mm). Tiles were fastened by either a gob of mortar or metal pins; many were placed upside down. The type of makeshift wooden batons that these were attached to seems to indicate that the roof had been re-tiled in the late 19th or early 20th century (Fig.46), perhaps at the time of the building's conversion to a village hall. During the development, the structure was re-tiled utilising a predominant quantity of the original tiles (Fig.47).

Fig.45. Roof tiles.

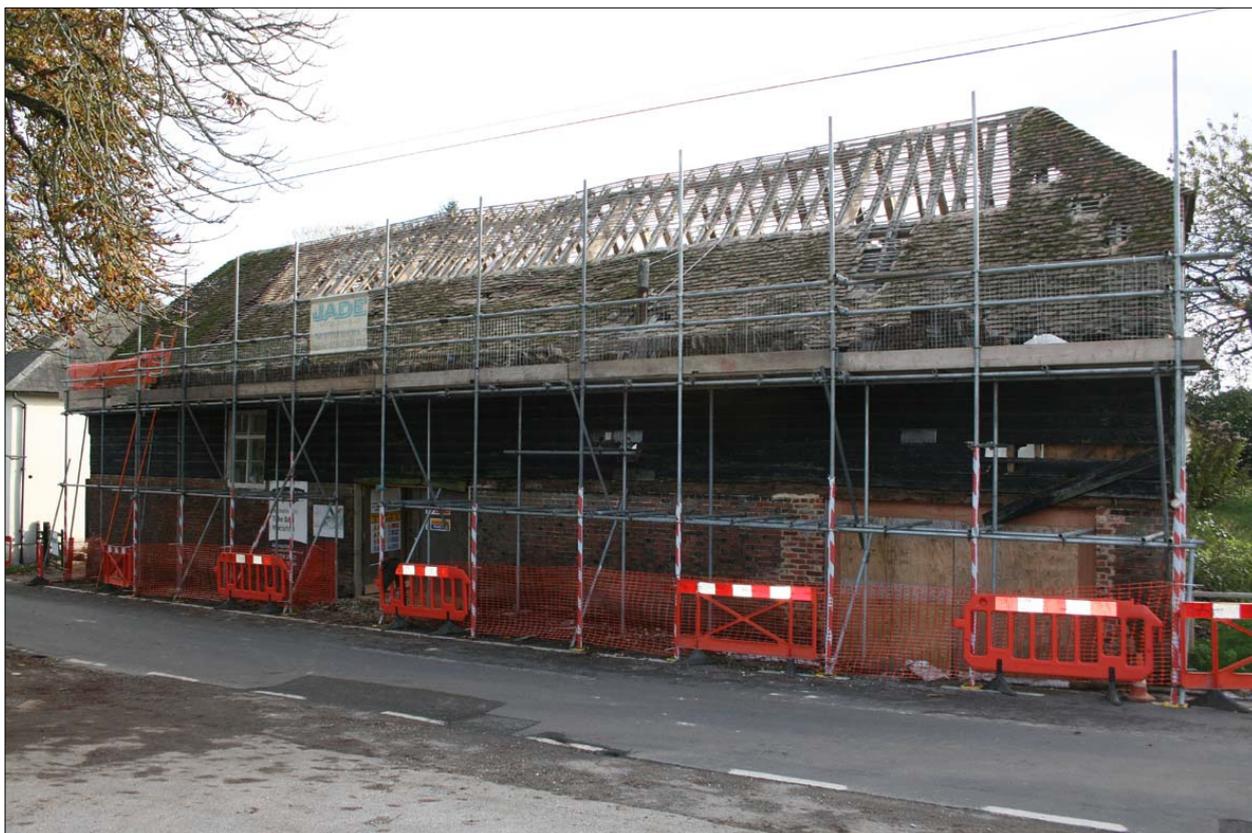
Fig. 47. North elevation during tile stripping. Facing south-east
