**The Hartshill Castle Research Project,  
Hartshill Warwickshire (Scheduled Ancient  
Monument)**

**Date:** 2006 onwards

**Archaeology**

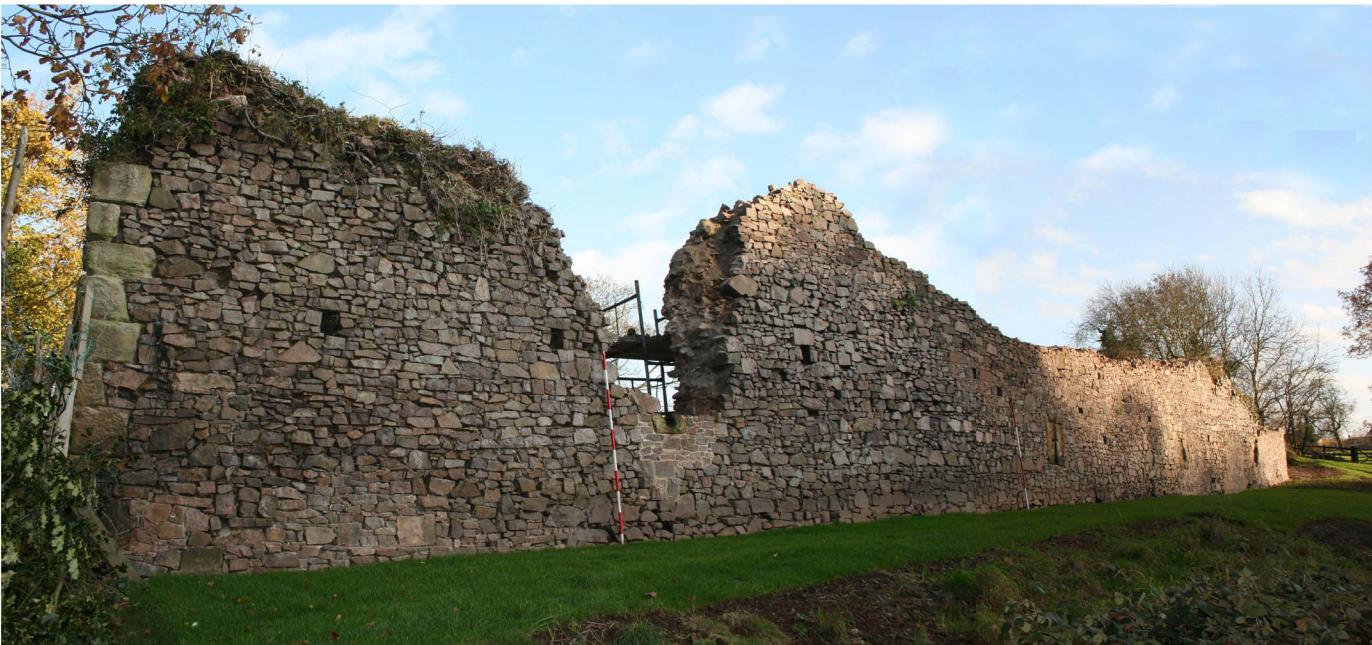
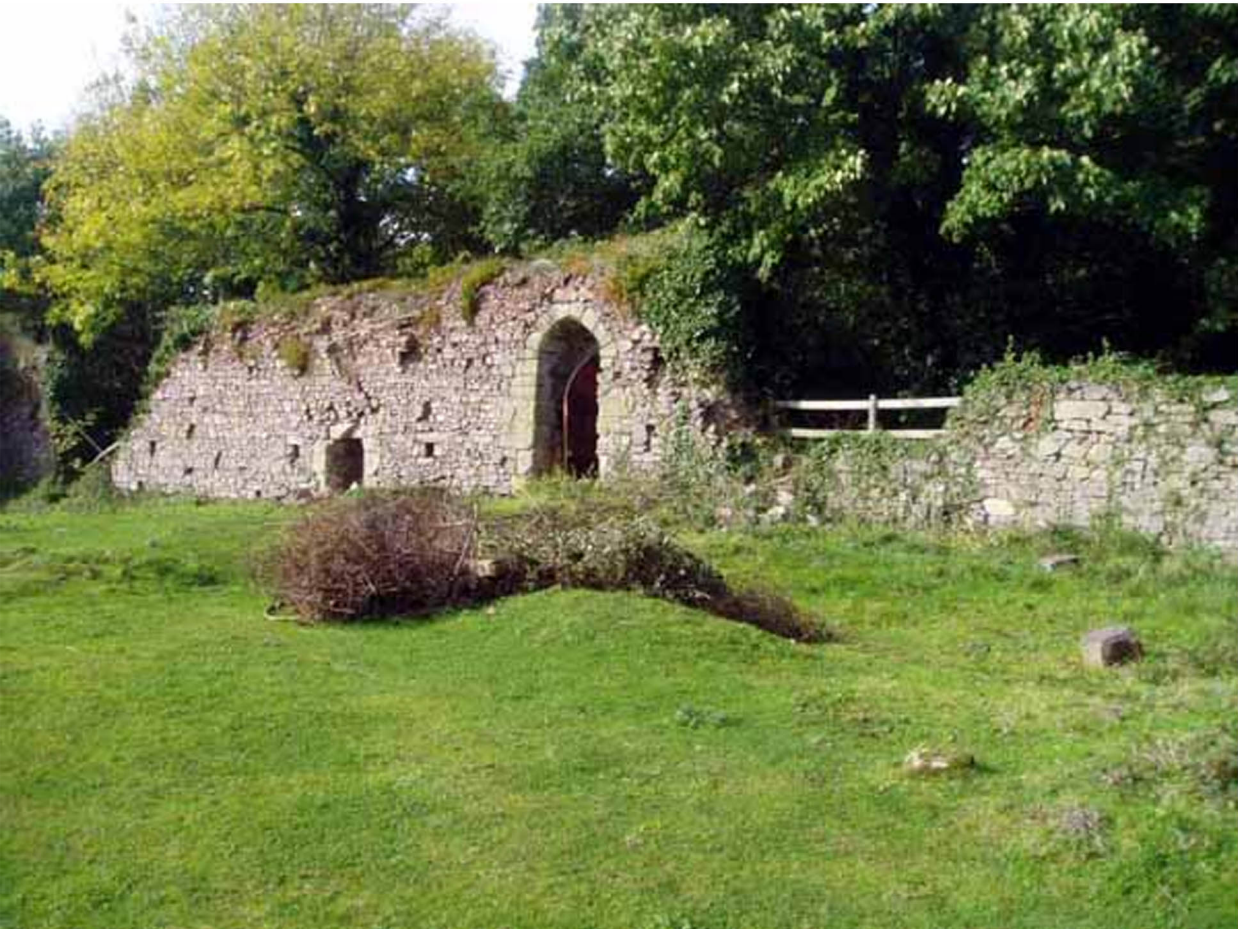
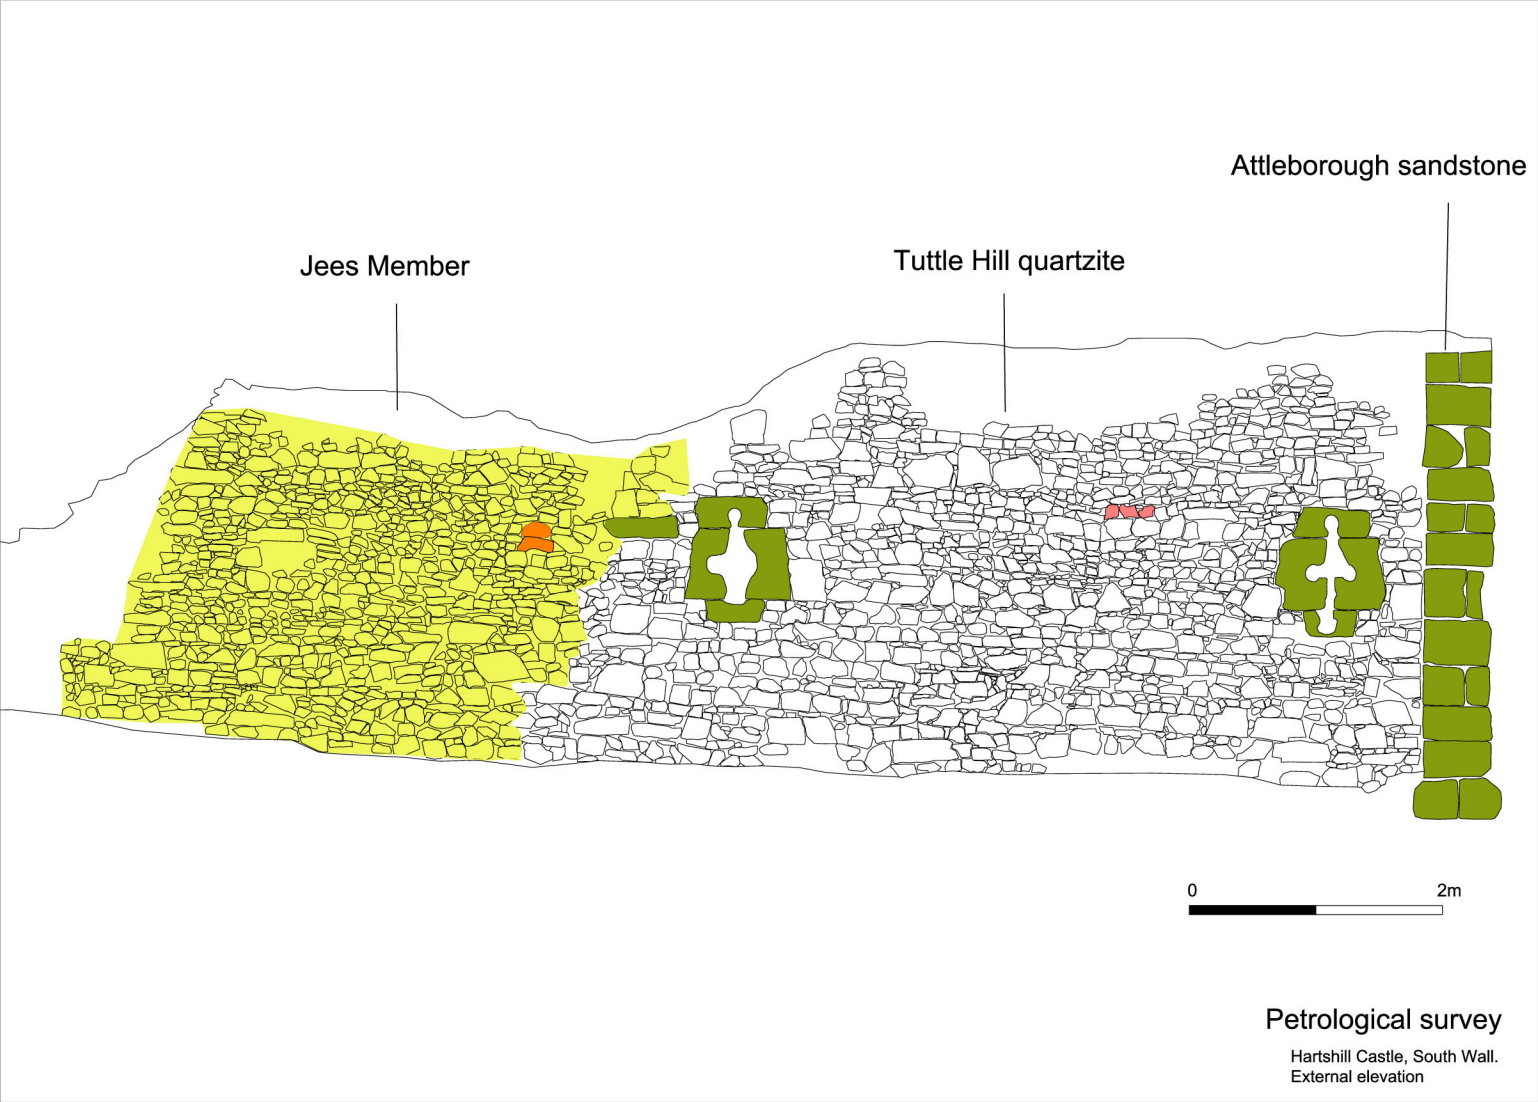
Once vegetation was stripped, the walls were recorded and examined in turn in an attempt to ascertain chronology. They are not easily dated, for the main body of each stone wall is built of quartzite, and historical phases are denoted by changes which are often quite subtle. Coigns, loop-holes and other 'feature' stones have been carved from local sandstone. Because accurate detailed survey is critical to the analysis of the structure a stone-by-stone record is necessary for each wall elevation. This has done by means of Total Station survey and rectified photography, following which the stones were digitised in AutoCAD.

The resultant line drawings are employed as analytical tools; physical changes in construction technique are not always clear in the field or on photographs. Drawings are also used on site for close examination of the wall fabric. Observations are made of stone size, shape, and the patterns of laying according direction of the grain of the stone, to establish a provision sequence of phases, following which petrological analysis is applied. Documentary research revealed that the castle walls were repaired and partially reconstructed in the late 18<sup>th</sup> and early 19<sup>th</sup> centuries by its owner, John Ludford of Ansley. The petrological application has permitted a comprehensive understanding of the extent of this work on the east, north and south wall on account of the exact source of stone being identified and a close date known for its extraction.
