## WREST PARK, SILSOE, BEDFORDSHIRE: BUILDING SURVEY OF AN 18<sup>TH</sup> CENTURY HYDRAULICS SYSTEM

PROJECT CODE: SOU-07/57

Date of survey: 23-24 April 2007

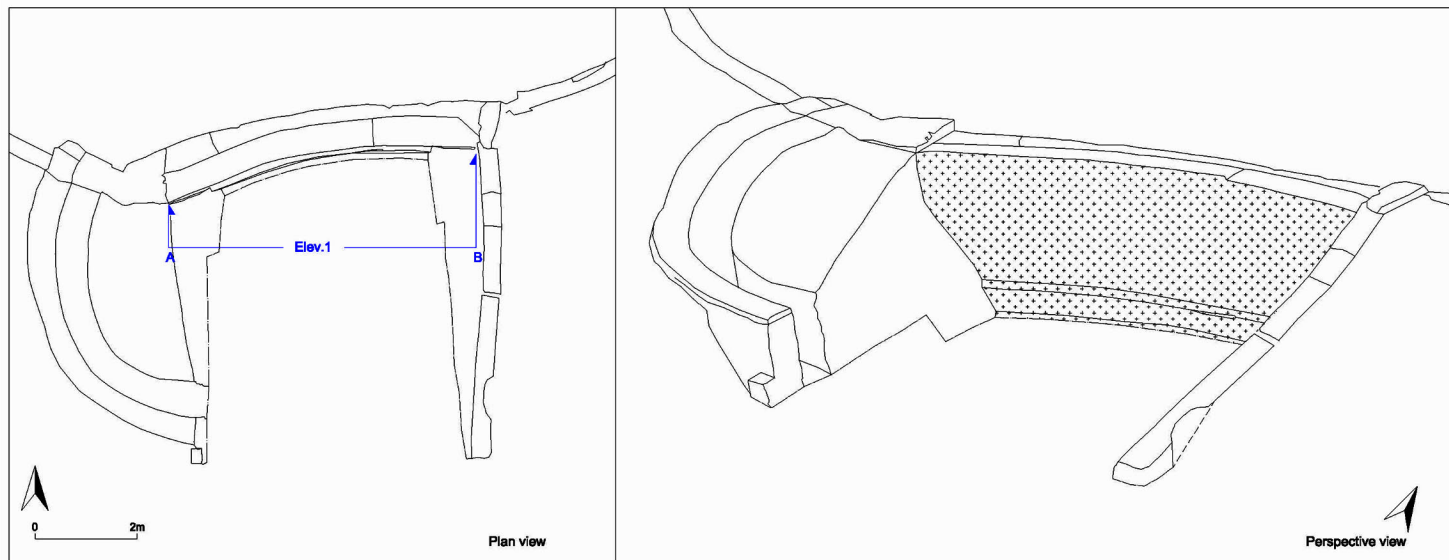
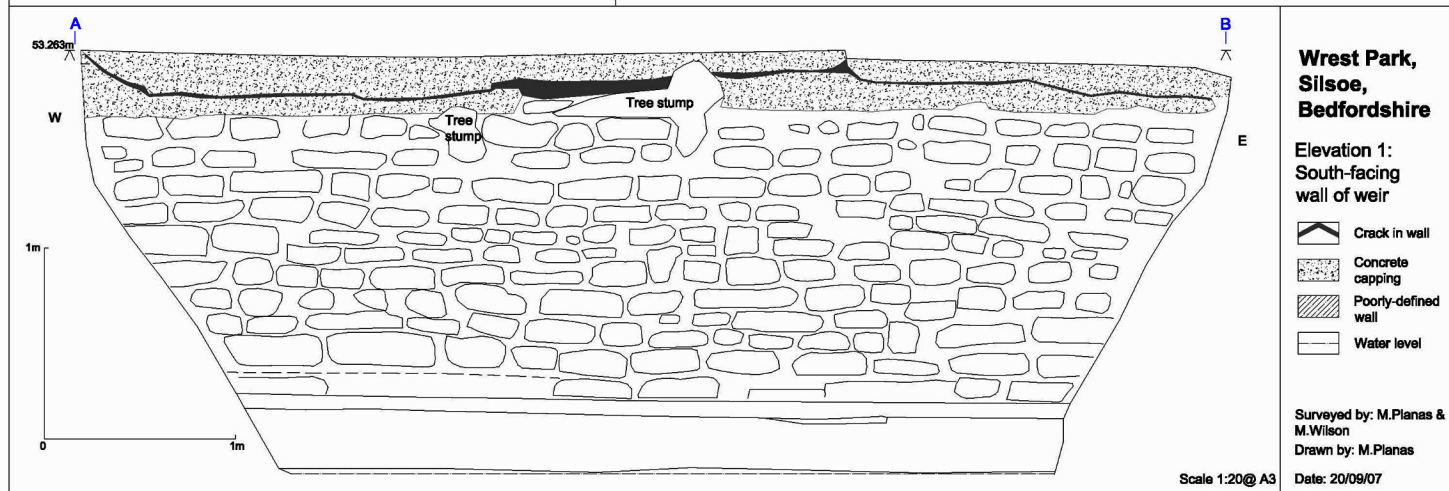
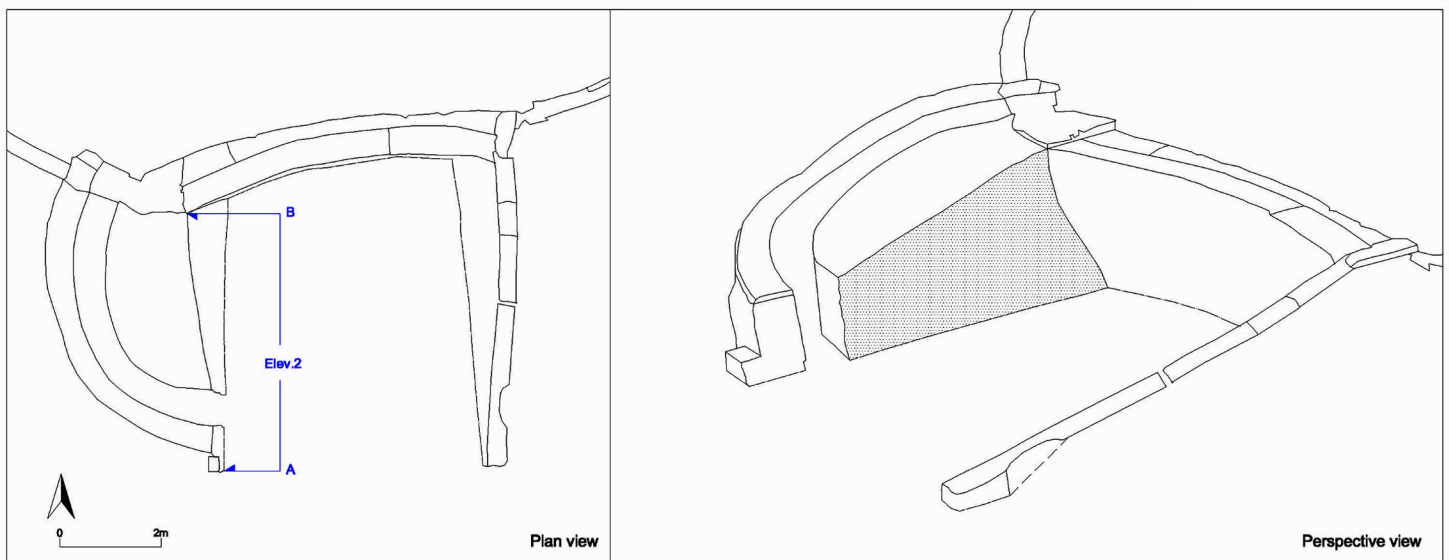
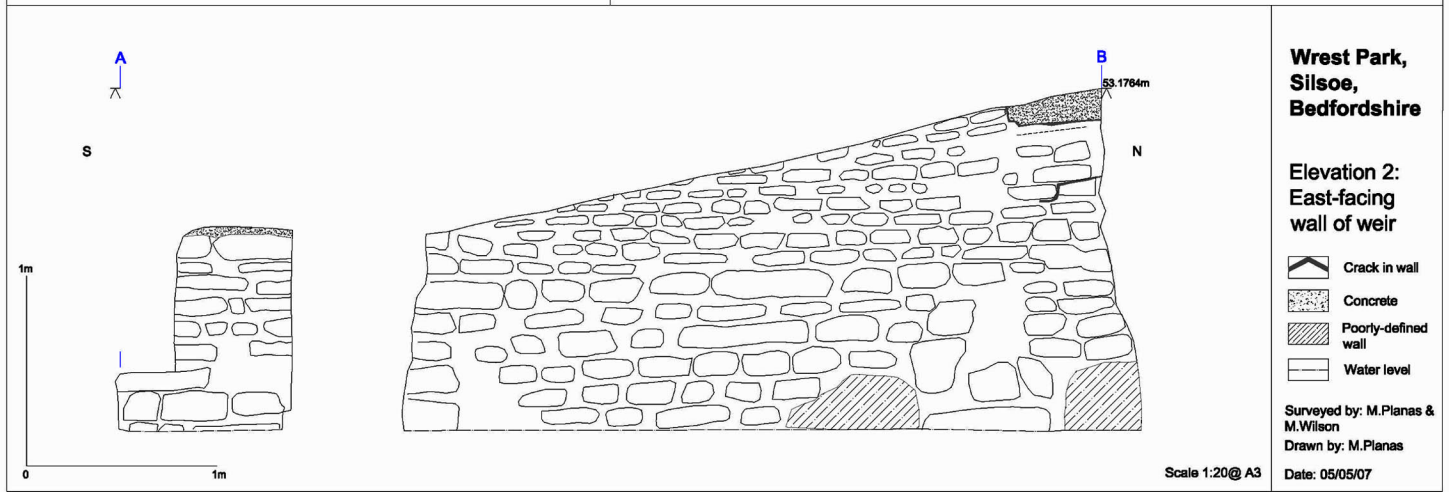
- An outline survey of the structure was first obtained by Total Station, following which elevations were recorded by computer-rectified photography (selected as a fast and effective means of recording). Target points were arranged to give total coverage of the structure and points were surveyed using reflector-less Total Station.
- Digital photographs were taken of each elevation, computer-rectified, and the stonework detail was digitised in AutoCAD.
- Due to limited visibility of the structure due to water level the elevation recording work was carried out in two stages, the lower levels were recorded in a limited window of opportunity during repair work when water levels were artificially controlled.

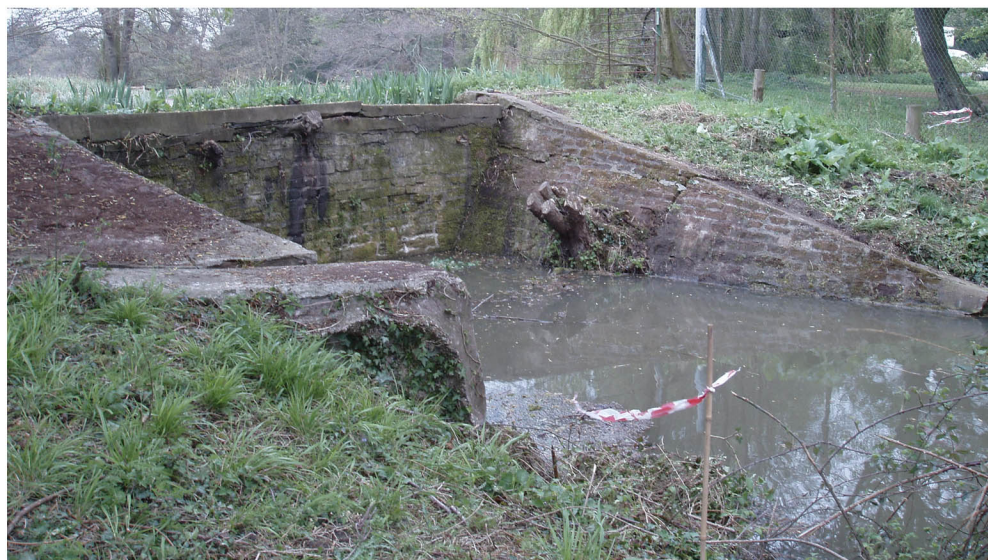
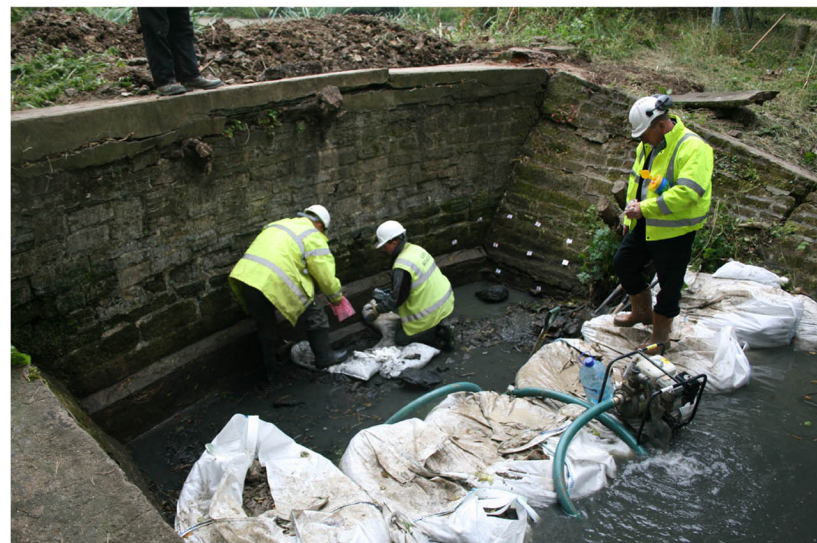
- A dual frequency GPS system was used to establish OS co-ordinate system control points at the site, following which a plan of all visible (i.e. above water level) features of the dam was made using a Leica Total Station.
